Town of Legal

Asset Management Review of Utility and Road Infrastructure

Date: December 2021

Project #: 60658079

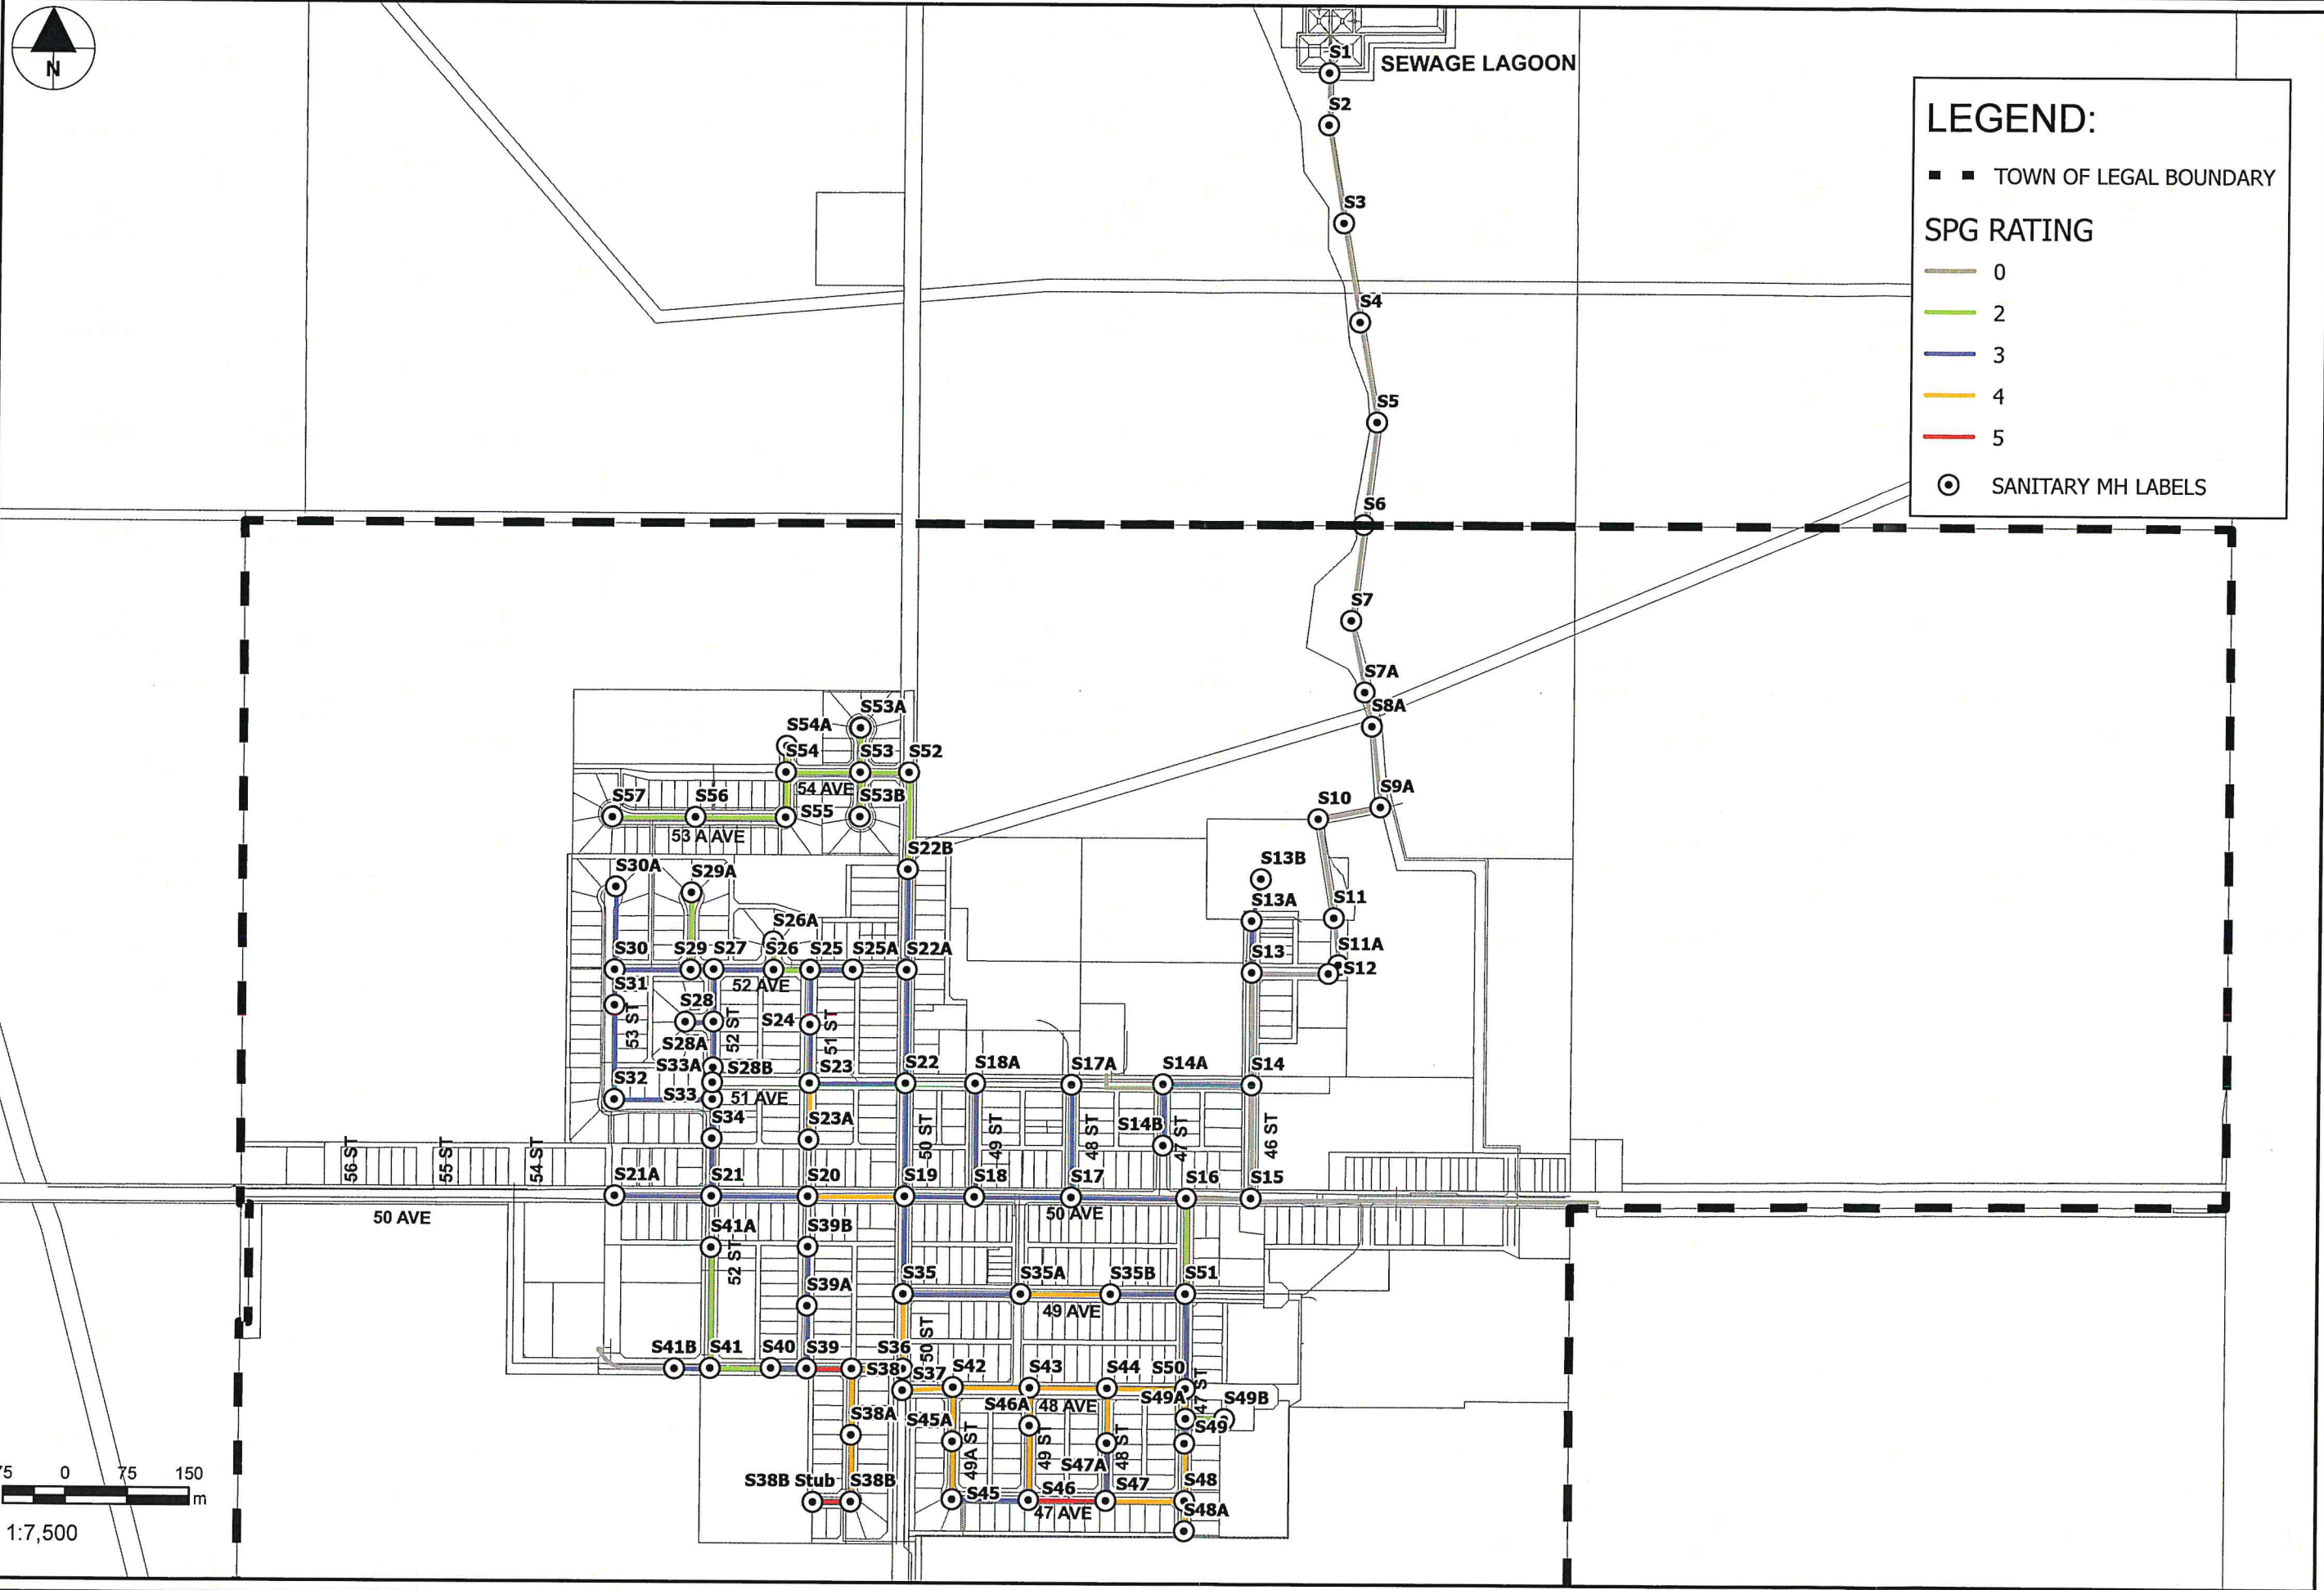
Chart 3-1 summarizes the SPG's for the sanitary assets as a percentage of the total inspected length surveyed. This gives a general indication of the state of the system, as well as where the system is in its service life cycle.

Structural Performance Grade is also illustrated on Figure 3-1.

Table 3-7: Repair Costs by Priority

Repair Type	Repair as soon as practical (SPG 5)	Repair in the near future (SPG 4)	Lining Program (SPG 3)
Repair Cost	\$204,900	\$510,800	\$1,069,200
Engineering & Contingency (40%)	\$81,900	\$204,300	\$427,700
Total	\$286,800	\$715,100	\$1,496,900
