Town of Legal

Asset Management Review of Utility and Road Infrastructure

Date: December 2021

Project #: 60658079

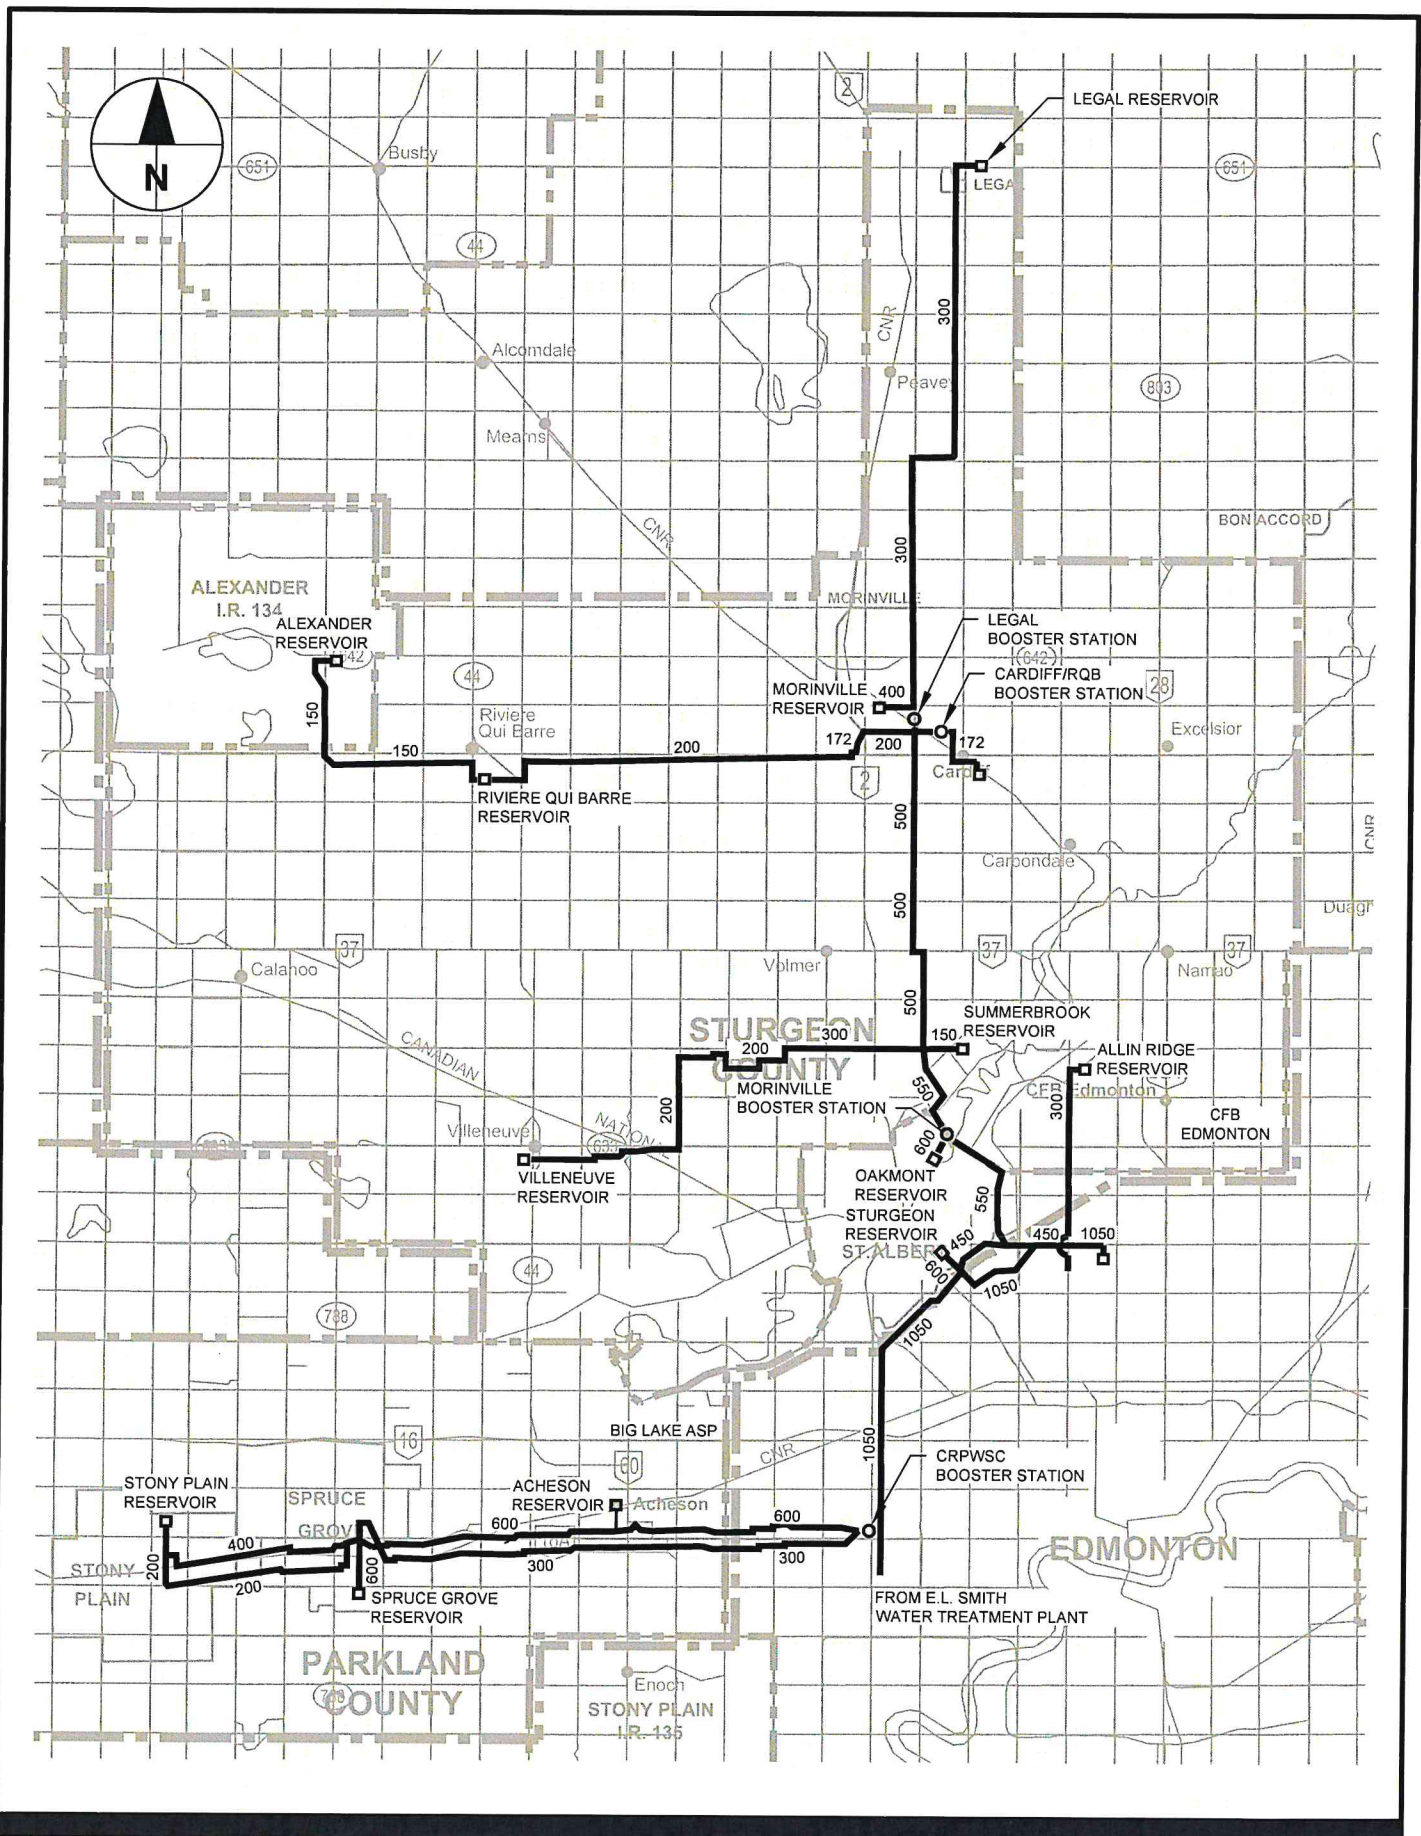
Figure: 2.3

The Town of Legal receives water from EPCOR via the Morinville Booster Station, located in St. Albert that increases the pressure in the transmission main to supply Villeneuve, Summerbrook, the Riviere Qui Barre/Cardiff Booster Station, the Legal Booster Station, and the Morinville Reservoir. The Town of Legal has a dedicated booster station to fill its reservoir. Figure 2.3 shows existing water transmission system to the Town of Legal.

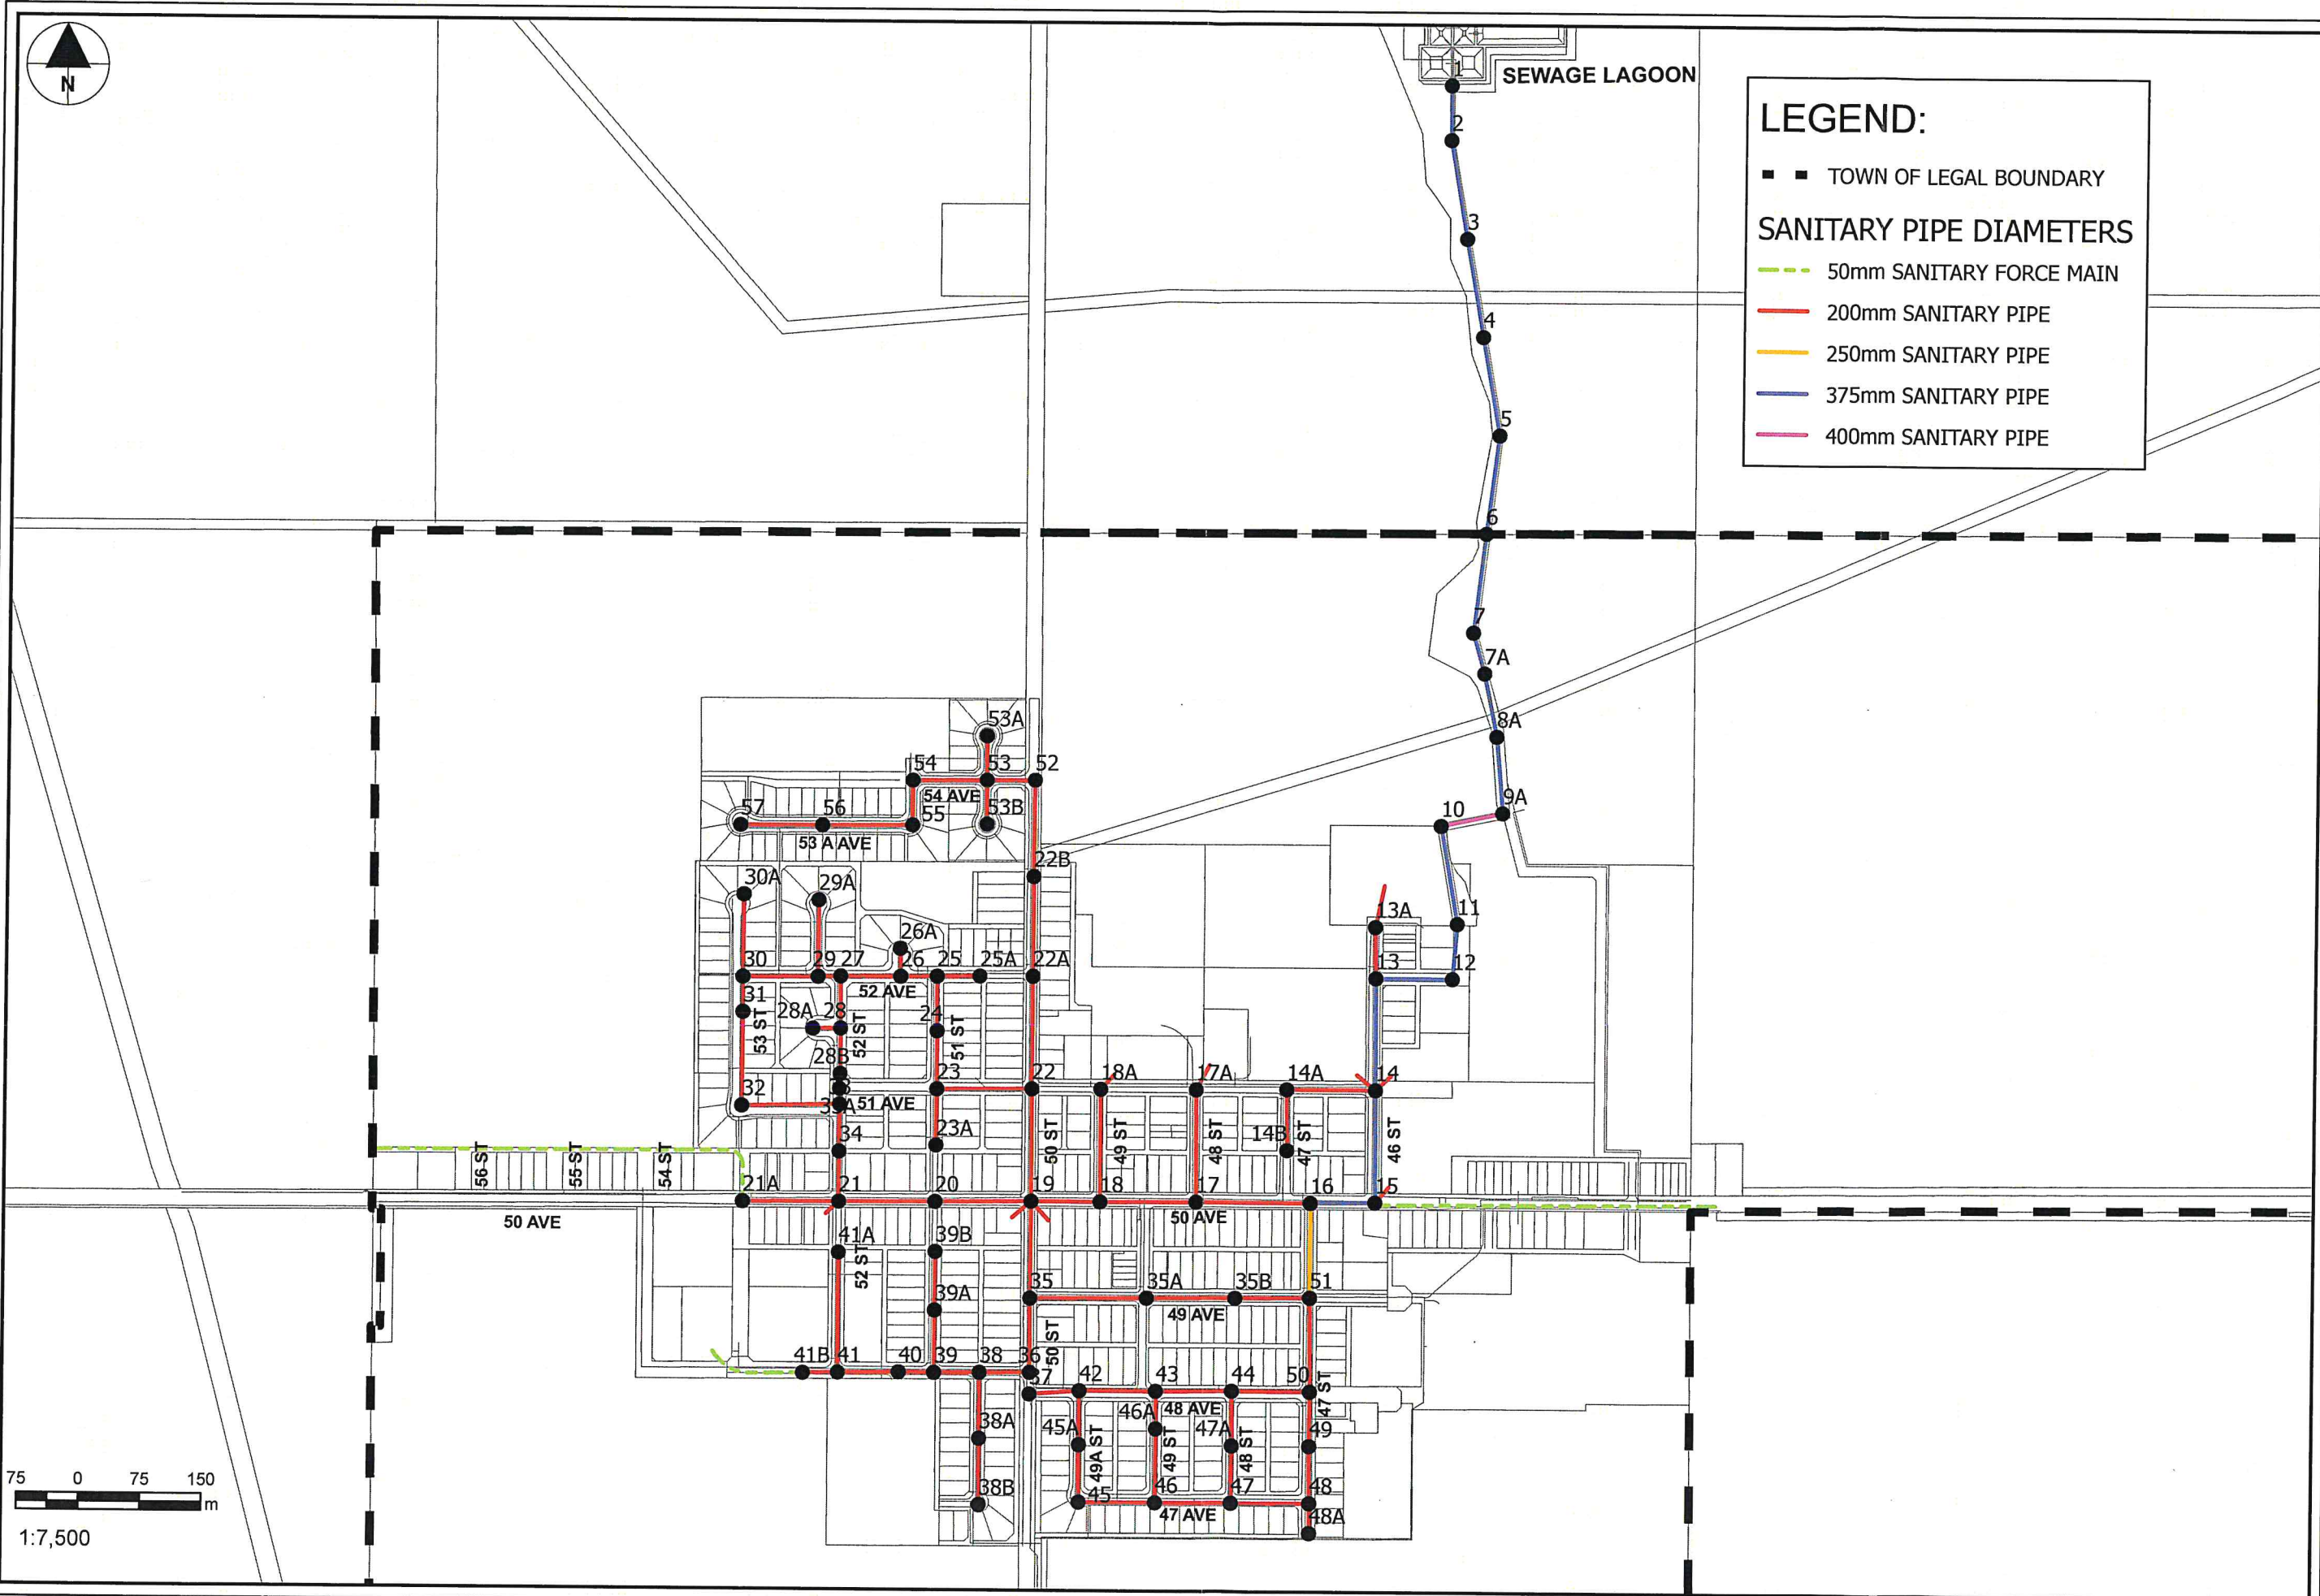
AECOM
Figure: 2.11

functional, there are no properties currently serviced to this line yet. Figure 2.11 shows the Town's existing sanitary system.

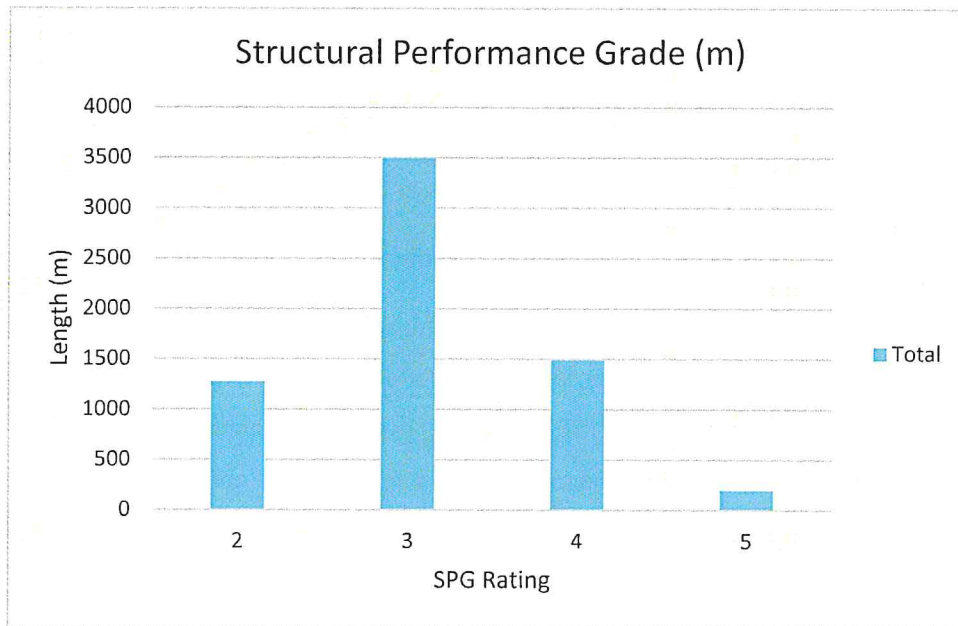
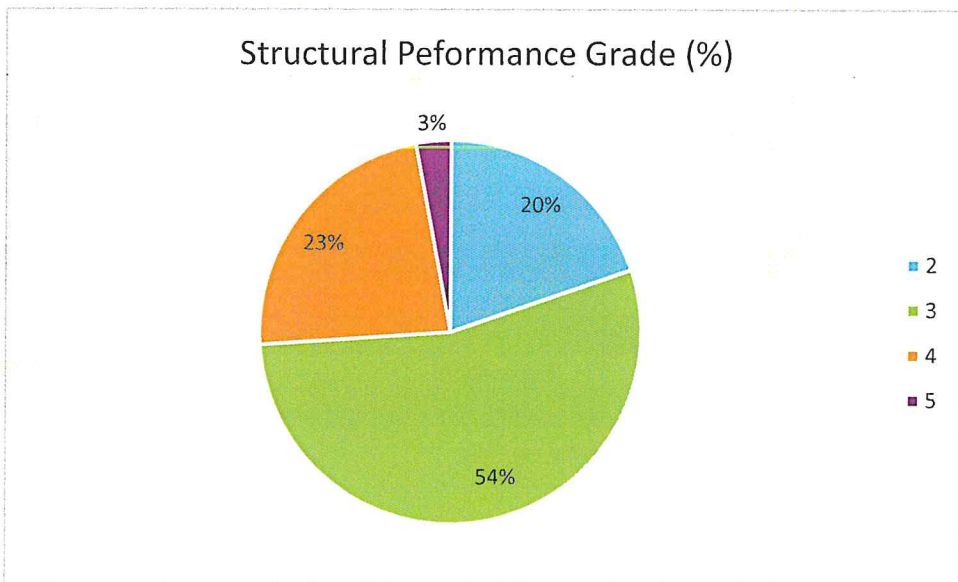
Chart 3-1 Structural Performance Grade Summary

Chart 3-1 summarizes the SPG's for the sanitary assets as a percentage of the total inspected length surveyed. This gives a general indication of the state of the system, as well as where the system is in its service life cycle.

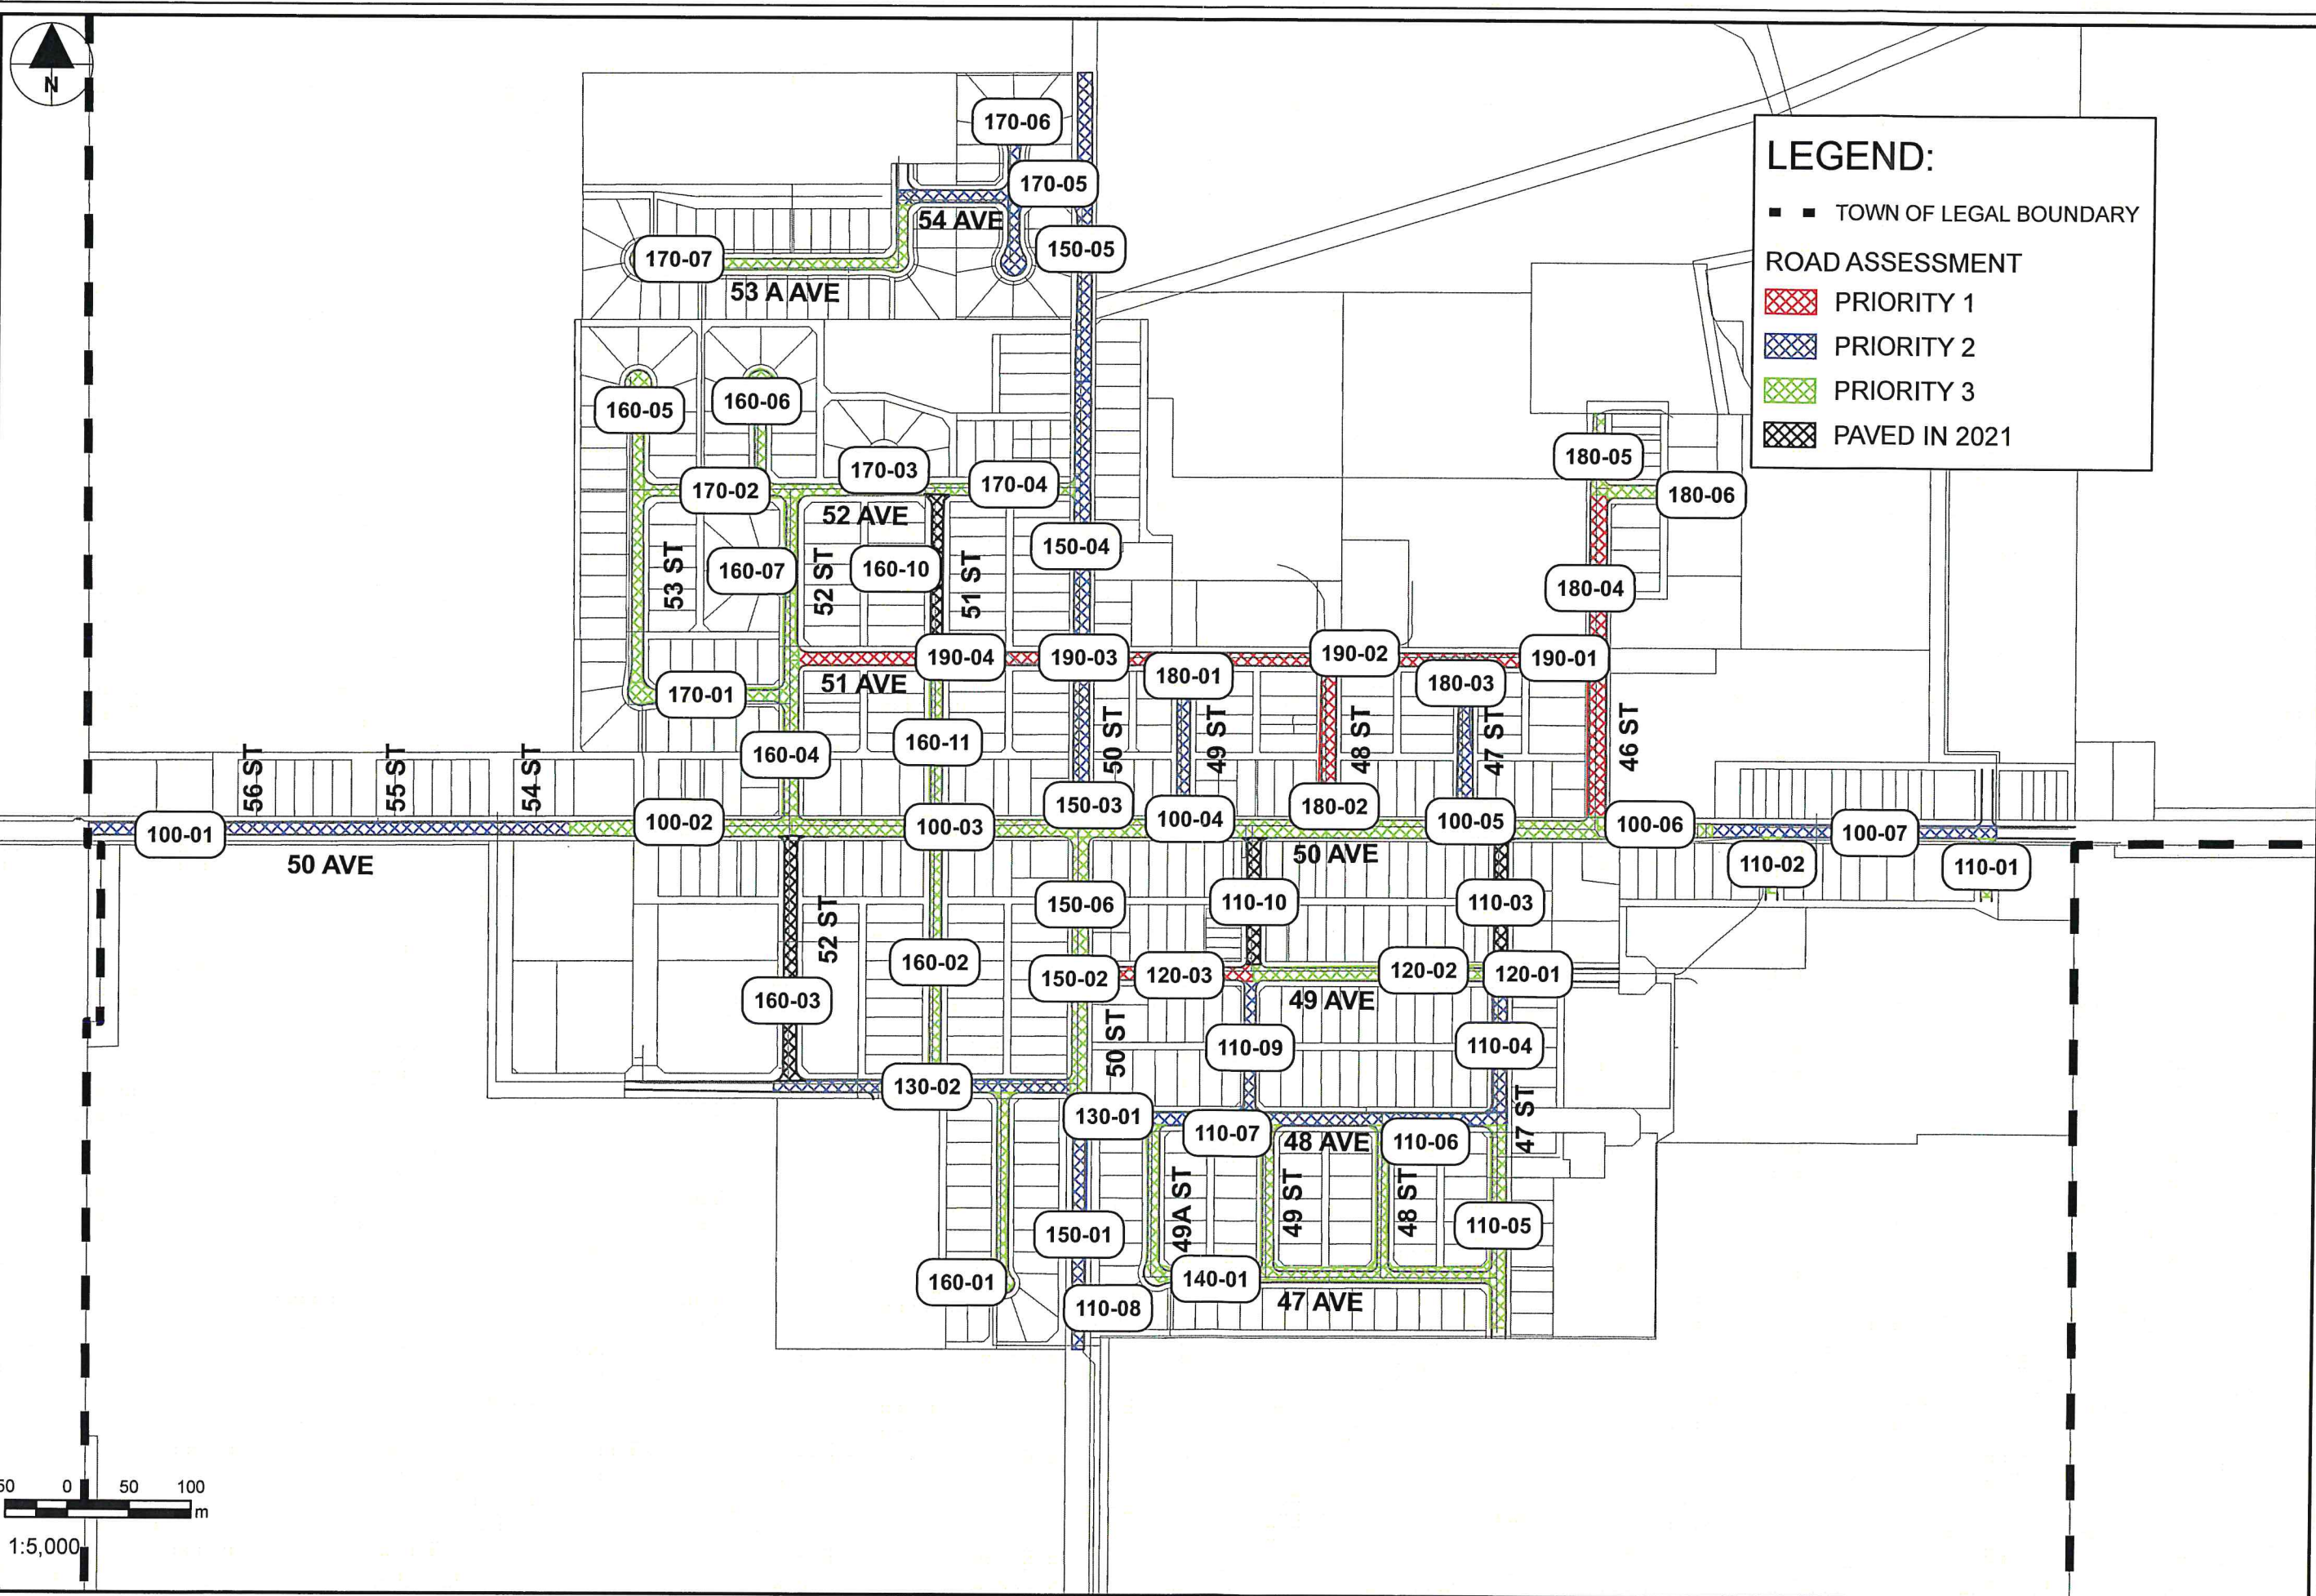
As pavement crack is the most common distress type, which is likely the result of cold temperatures during the winter months, an effective crack sealing program should be maintained to ensure moisture entering the road base is minimized.

The program provided is based on a road network analysis to determine which pavements should receive what type of rehabilitative treatment and when it should occur. At a project level design, each section would undergo a more detailed scope of work on pavement design and other street upgrades at the time of rehabilitation.
